# MINING SUBSIDENCE AND GEOTECHNICAL ASSESSMENT

Response to Ipswich City Council  
Information Request - Item 1

**2 Morris Street**  
Tivoli QLD 4305

LOT ON PLAN  
Lot 43 on  
RP14624

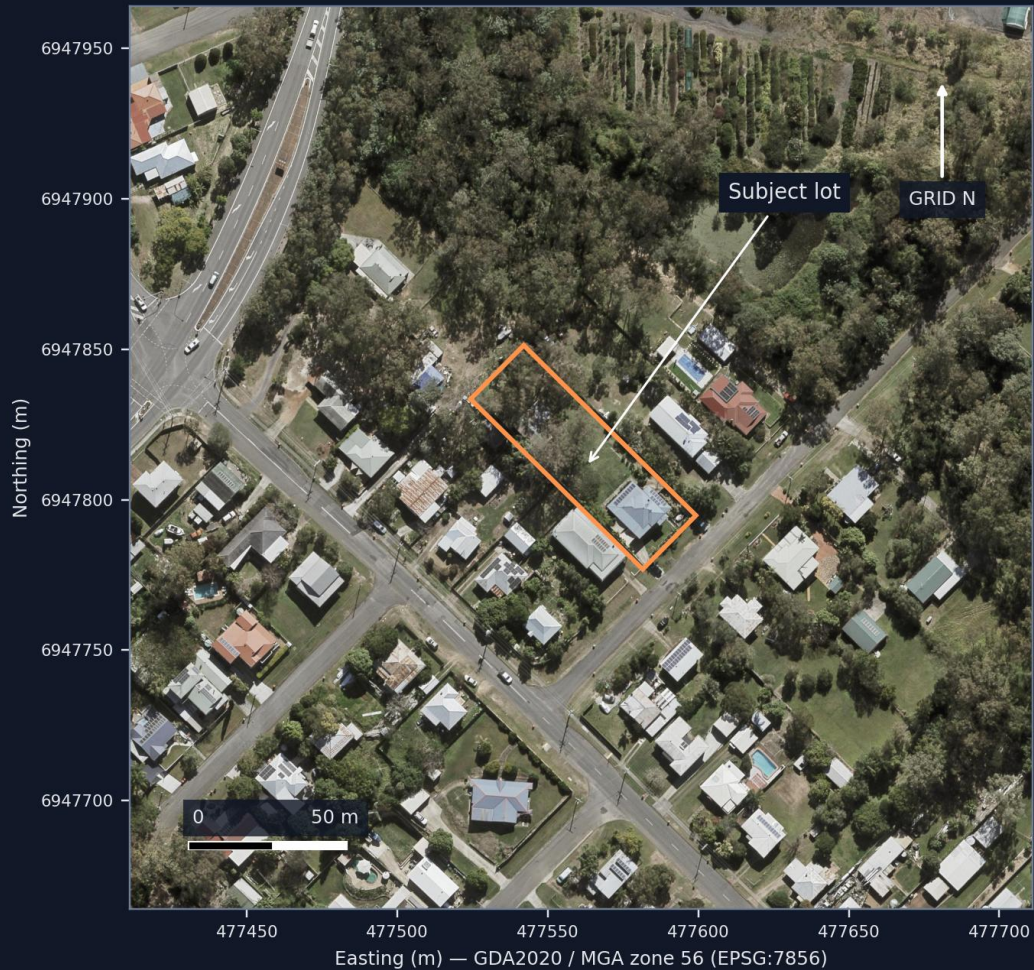
Figure 1 Site and surrounds on State aerial and cadastral context

State aerial and cadastral context; existing development shown at capture date.

Aerial: Ipswich 2022, raster 5671; cadastre: Queensland, retrieved September 2026.  
 © State of Queensland, CC BY 4.0. Cadastre is orientation only, not a survey.  
 RPEQ Consulting | 7 October 2026 | Factual draft for technical review

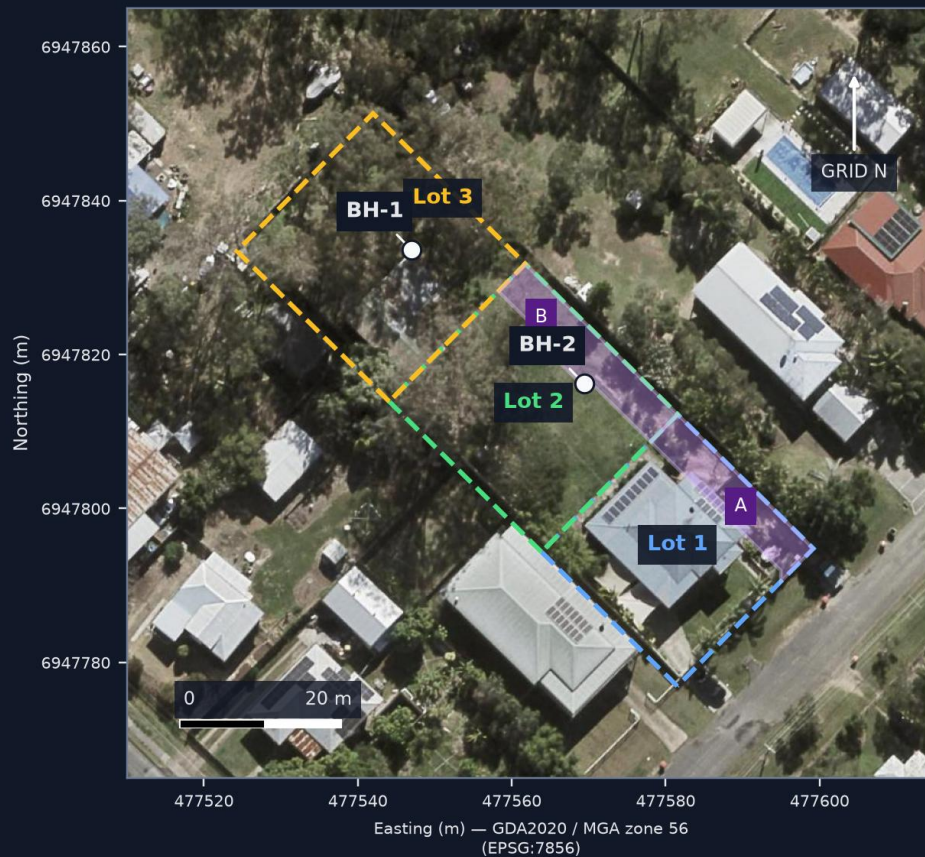
## Proposal and shallow investigation

Proposal 26-827 [B], 6 August 2026; IST job 26/2348, pp. 2-3  
Proposed boundaries fitted to cadastre; test positions indicative.

Dashed: proposed lots. Purple A/B: proposed access easements. White: tests.

No surveyed test collar RL, building envelope, finished pad level or mine workings is implied. Plotting precision does not establish location accuracy. BH02 CBR/PSD is a sample identifier; its civil design suitability requires separate adoption.

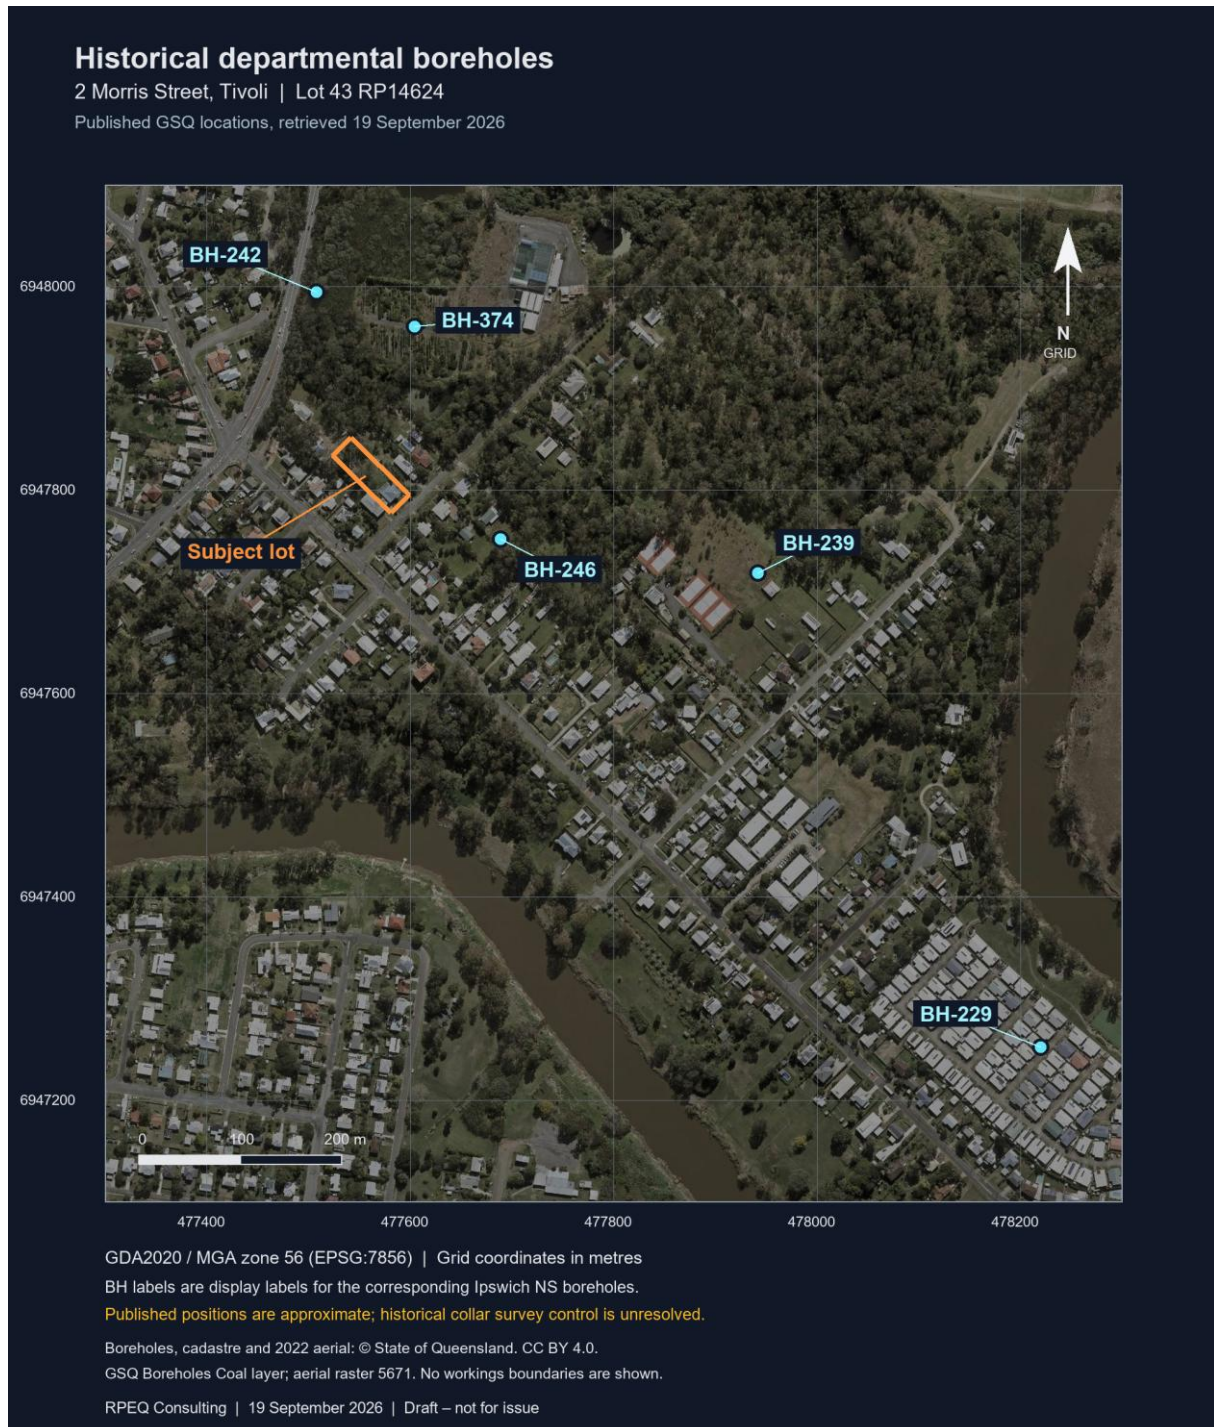
**Figure 15 Historical departmental borehole locations**

Source: GSQ (2026) borehole locations; Department of Development and Mines (n.d.-a-e); GSQ (n.d.-a-e). BH-229 to BH-374 are Ipswich NS 229 to NS 374. The cadastral outline is for orientation only.

1. Five departmental bores lie within about 860 m of the site; the nearest, NS246 and NS374, are about 140 m and 150 m away.
2. The published GSQ Report 30 section for NS374 corroborates the seam depths Taylor used: 37, 88, 105 and 176 m (Cameron, 1969, Figure 5, PDF p. 24; Taylor Mining Services Pty Ltd, 2026, Table 1).
3. NS246 recorded old Garden Seam workings with a 1.12 m tool drop and a 2.44 m drop in the Tantivy Seam, consistent with Taylor's working heights of 1.0 m and 2.7 m (Staines, 1964, PDF p. 6; Department of Development and Mines, n.d.-d, pp. 2 and 5).

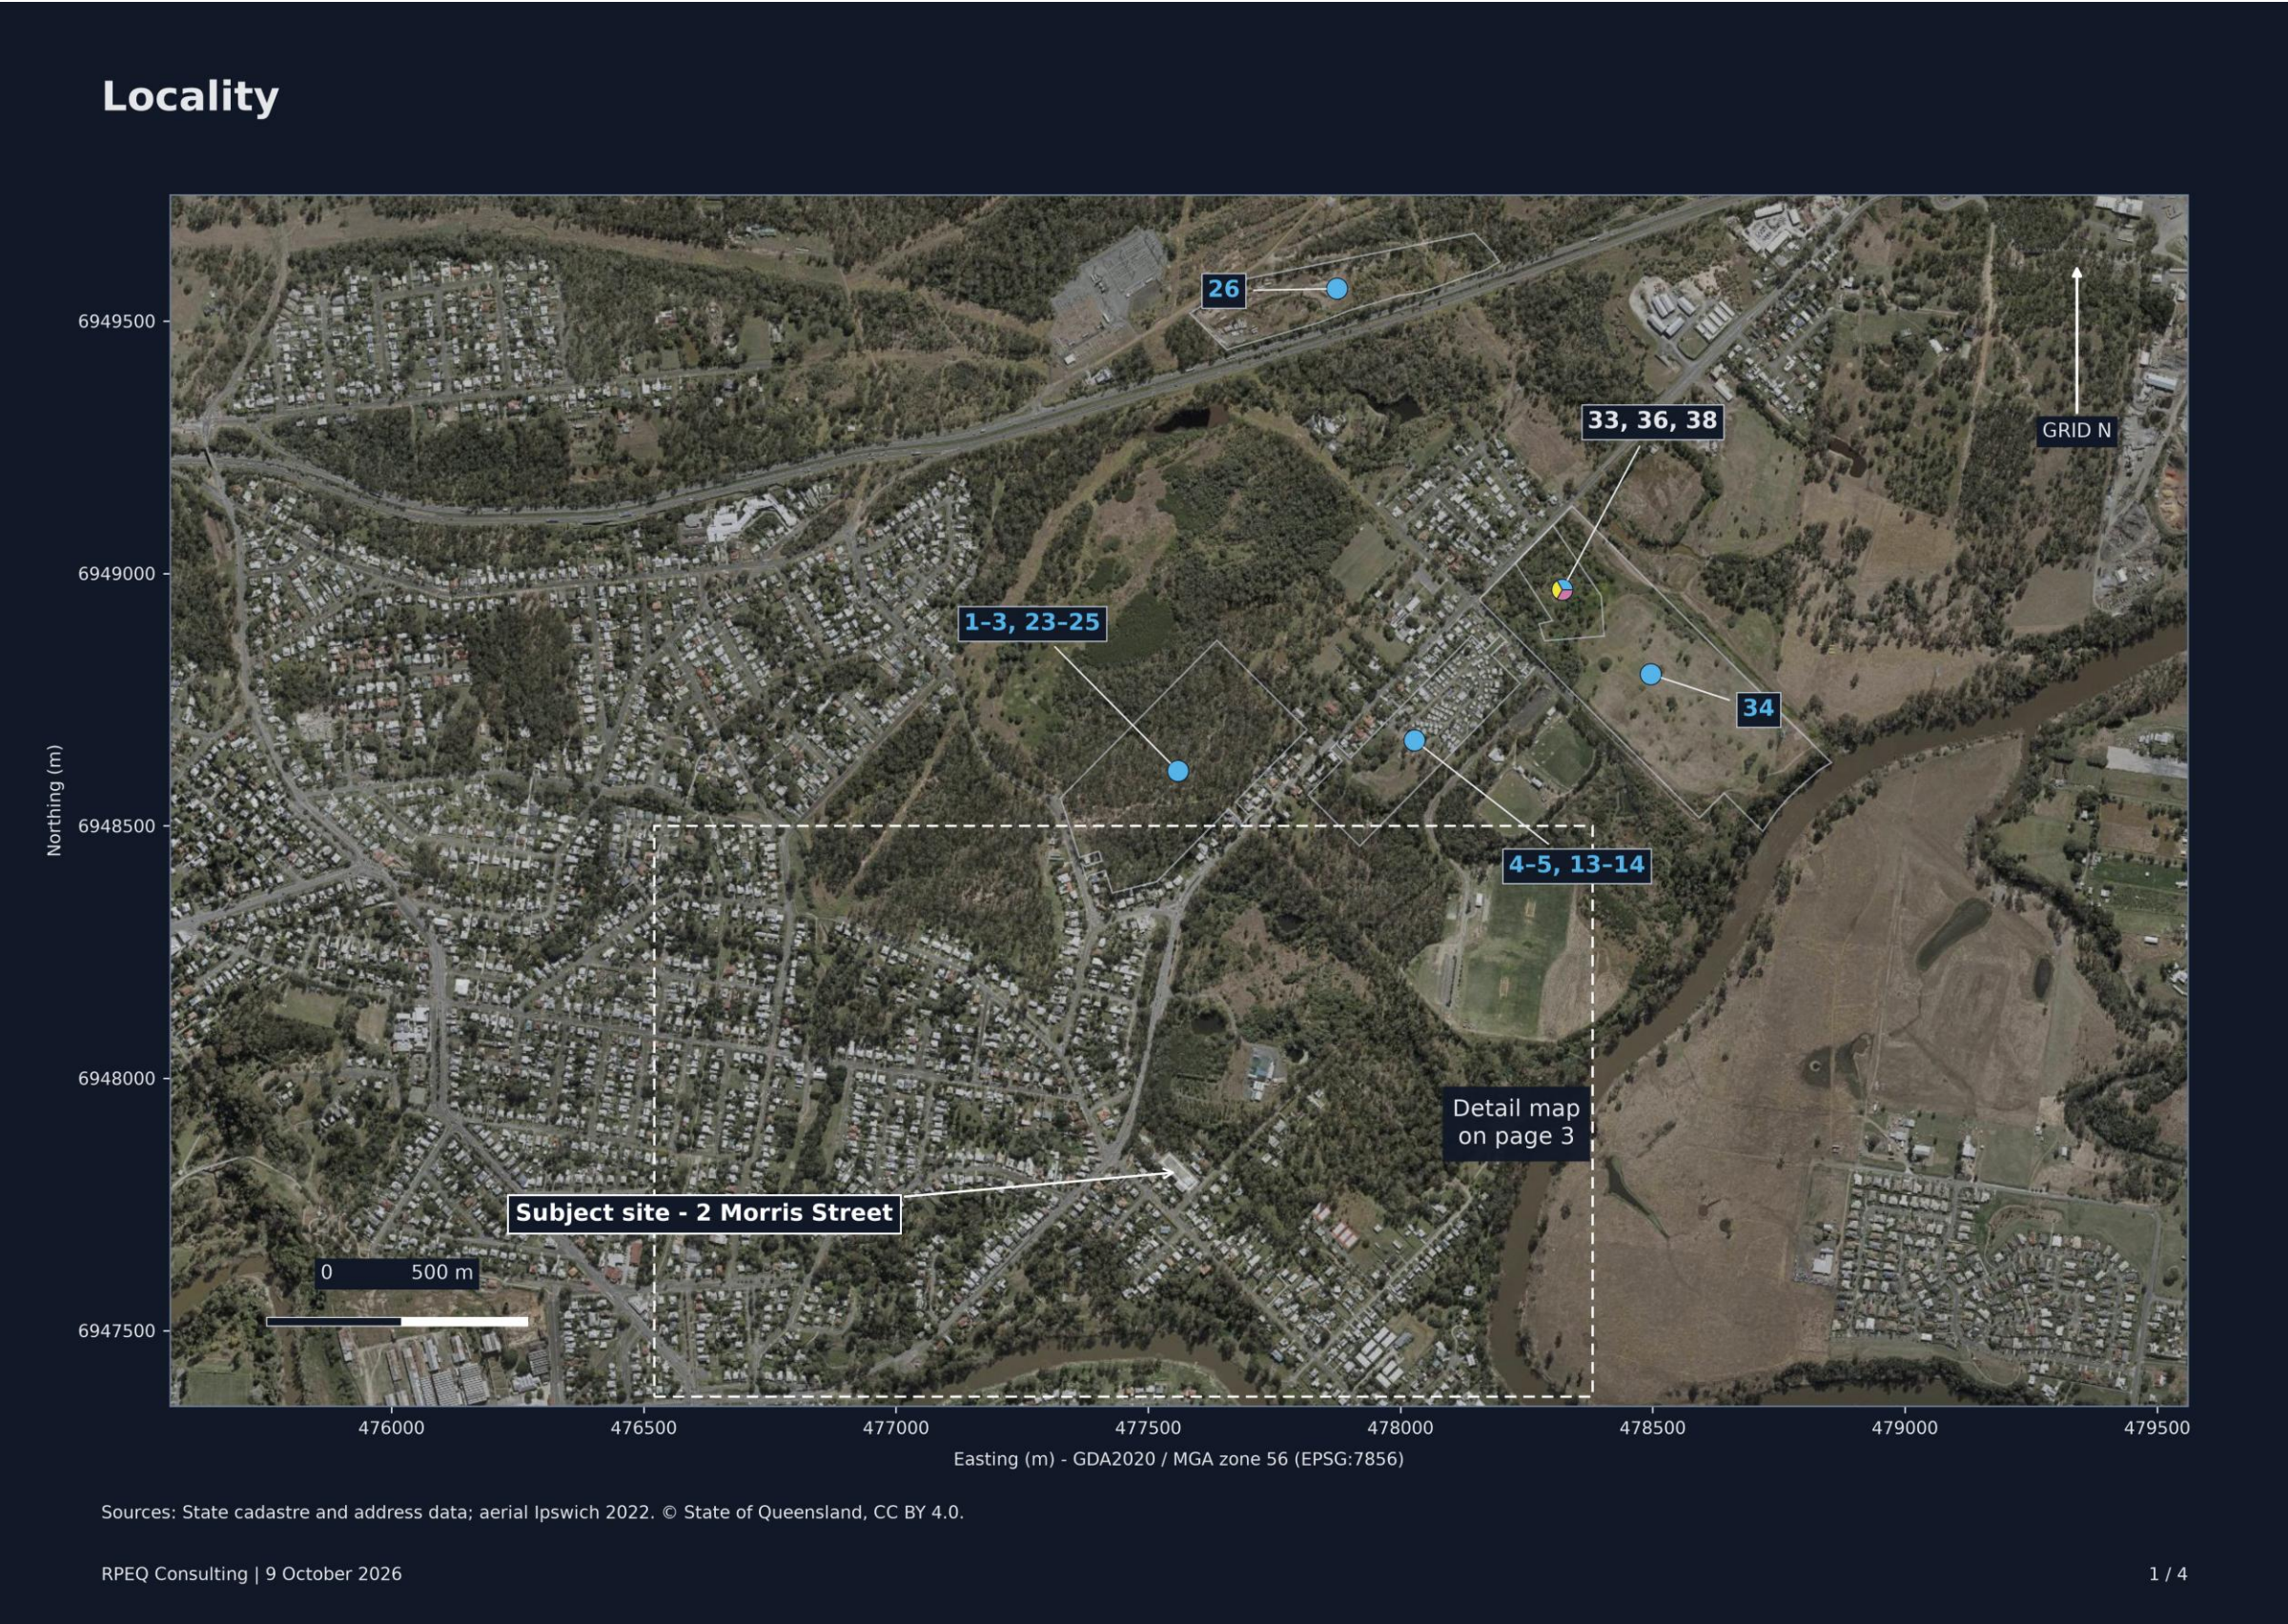
Figure 22 Tivoli development applications: locality map

This appendix lists 40 Tivoli development applications on mining-affected land, with the mining reports lodged for each and Council's decision and mining conditions. The # column matches the numbers on the maps (Figure 22 to Figure 25); row 29 could not be placed on the map. Full document details are in Section 12.2.

Appendix H lists 40 Tivoli development applications on mining-affected land, with their mining reports and Council outcomes, and maps them by number. Council approved comparable reconfigurations, including 7655/2010/RAL (22 Boundary Street, Lot 60 on RP14624, one lot into three; Appendix H #9), 7509/2010/RAL (38 Greasley Street; #6), 4371/2011/RAL (36 Greasley Street; #11), 5481/2014/CA (36 Moores Pocket Road, one lot into three; #18) and 10167/2024/RAL (34 Greasley Street; #31), on the basis of desktop mining studies with site or roadside inspection, subject to conditions requiring design to the mining report recommendations and RPEQ structural certification (ICC, 2011c; ICC, 2010b; ICC, 2011a; ICC, 2014b; ICC, 2025a).
